PRINCE GEORGE'S COUNTY
HISTORIC SITE SUMMARY SHEET

Survey #: P.G. #87A-10 Building Date: 1911
Building Name: St. Thomas Methodist Church
Location: 18810 Aquasco Road, Brandywine (Horsehead), Maryland
Private/Religious/Unoccupied/Fair/Inaccessible

Maryland Historical Trust State Historic Sites Inventory Form

historic St. Thomas Methodist Church

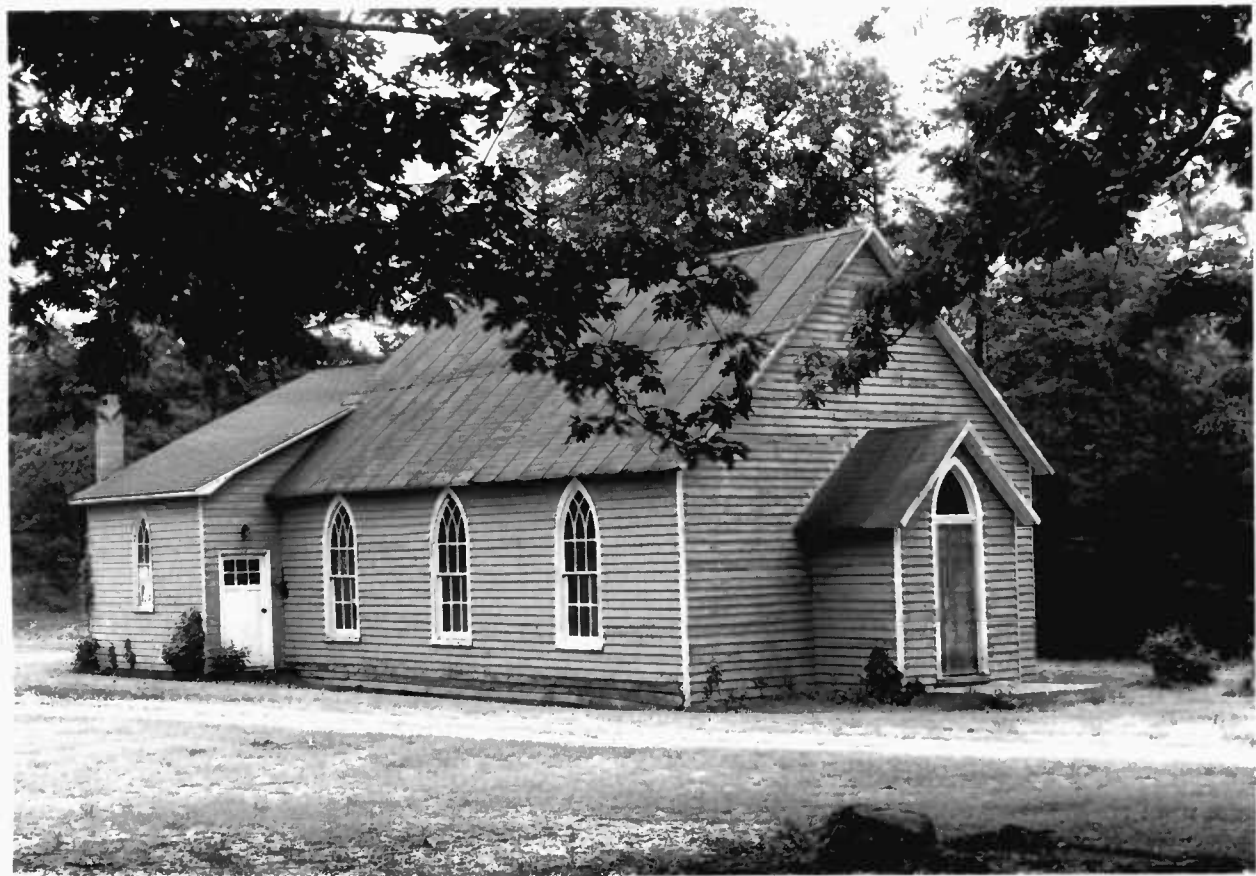
P. G. #87A-10

St. Thomas Methodist Church
Prince George's County, Md.
Susan G. Pearl
May 1983
Northwest 3/4 Elevation
Neg: Md. Hist. Trust, Annapolis, Md.

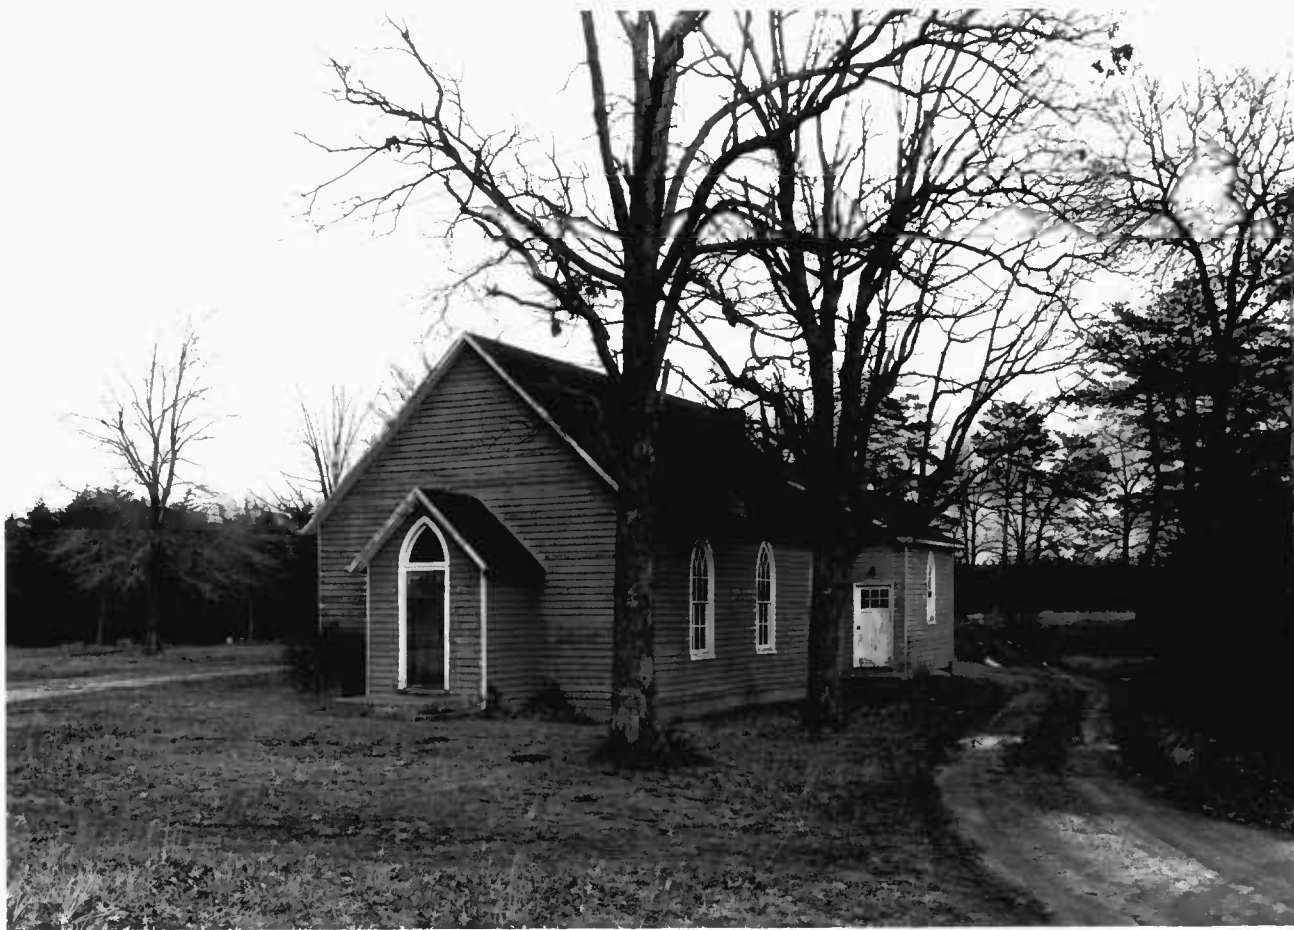
St. Thomas Methodist Episcopal Church 87A-10
Aquasco, Prince George's Co., MD PG82A29
Michael Hosford

Maryland Historical Trust, Annapolis, MD
Southeast elevation
1/81

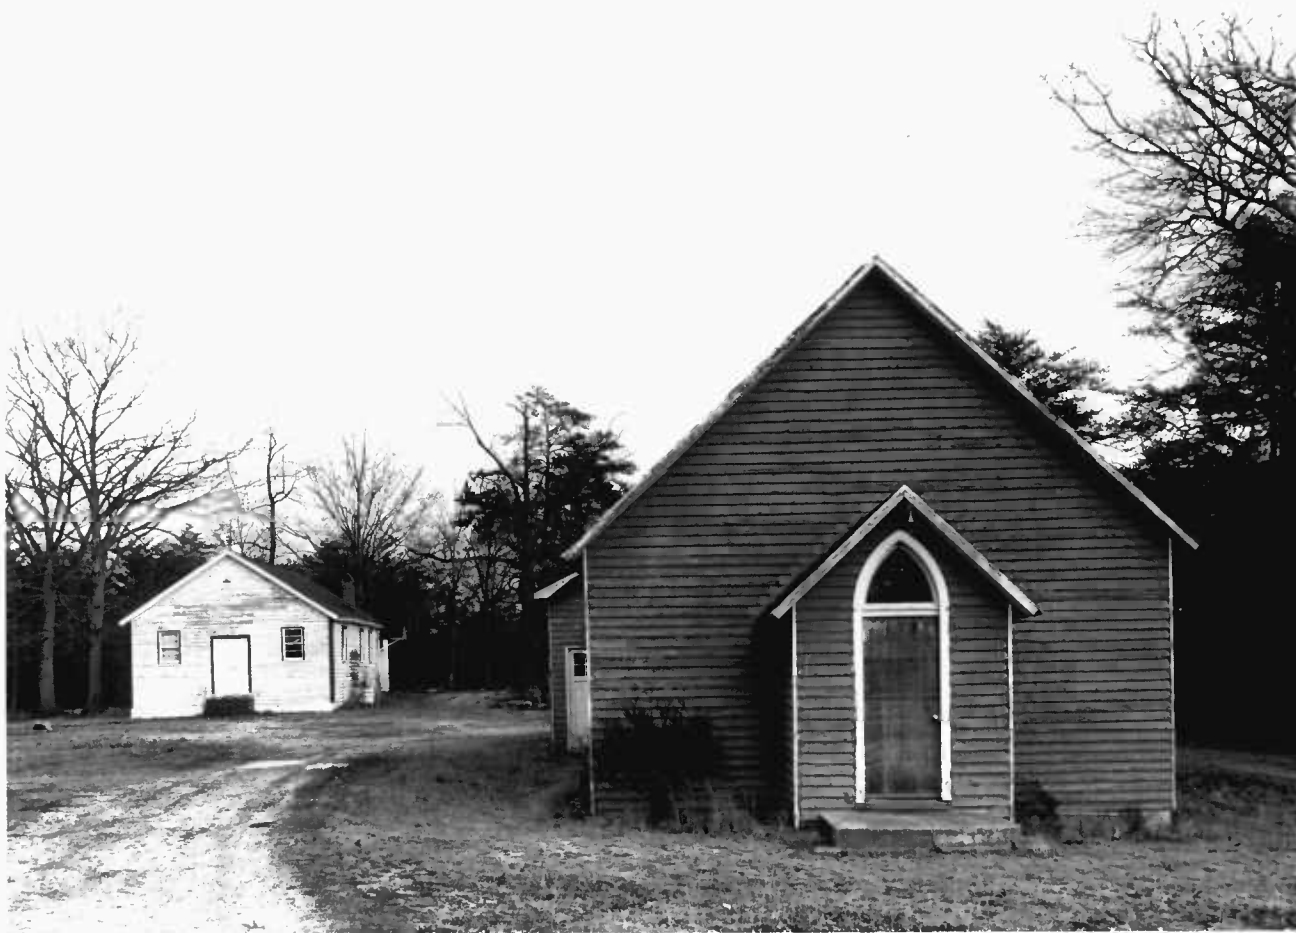
St. Thomas Methodist Episcopal Church 87A-10
Aquasco, Prince George's Co., MD PG82A29
Michael Hosford

Maryland Historical Trust, Annapolis, MD
South elevation
1/81

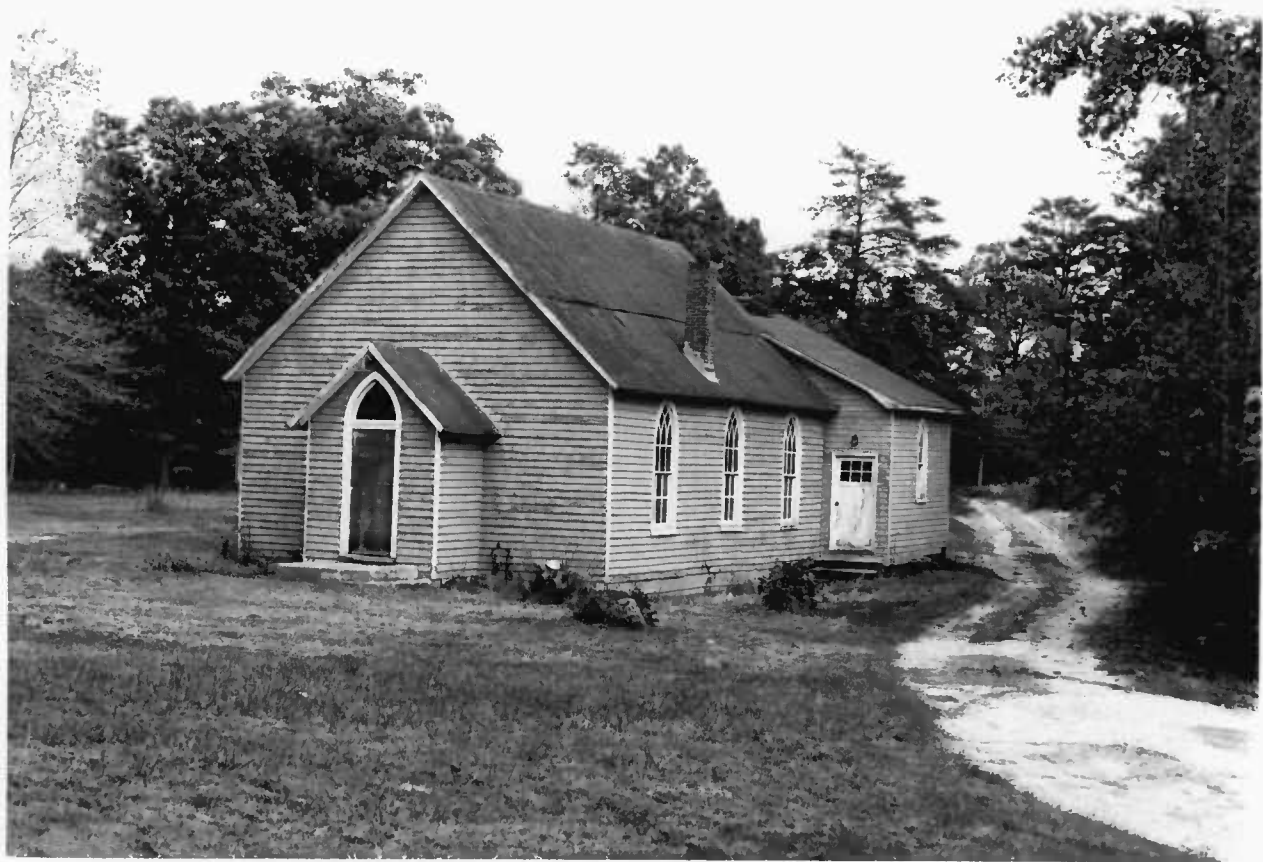
P. G. #87A-10

Southwest 3/4 elevation
